## Scotts Valley Planning Commission

**Date: March 14, 2019**

**Project Description:** Consideration of a recommendation to the Scotts Valley Planning commission for a Design Review of a new 624 square foot, two story, single-family dwelling with a two car garage in grading in slopes over 30%.

**213 Blueberry Drive**  
**APN 021-102-05**

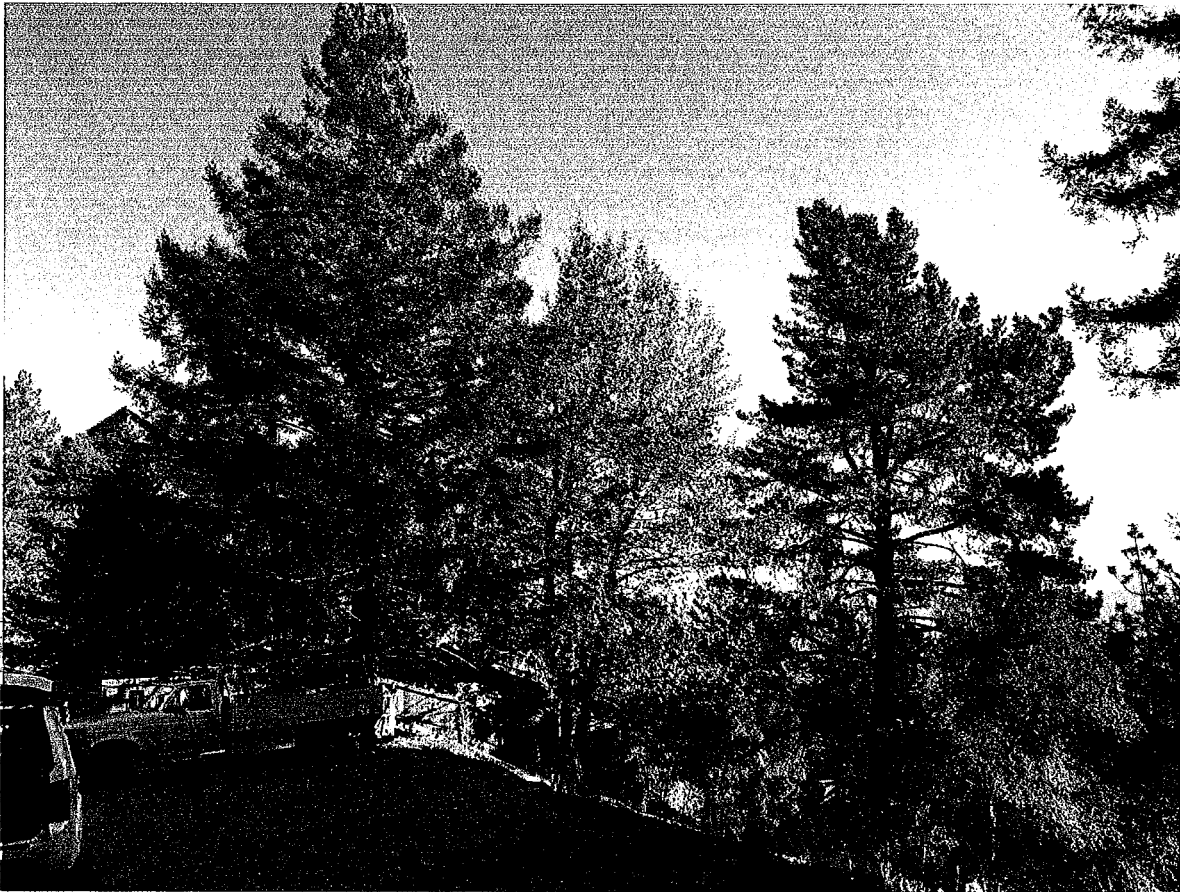
Image #1 – Trees T1, T2, T3 & T4 – Coast redwood, California bay laurel, Monterey pine & coast live oak, left to right.

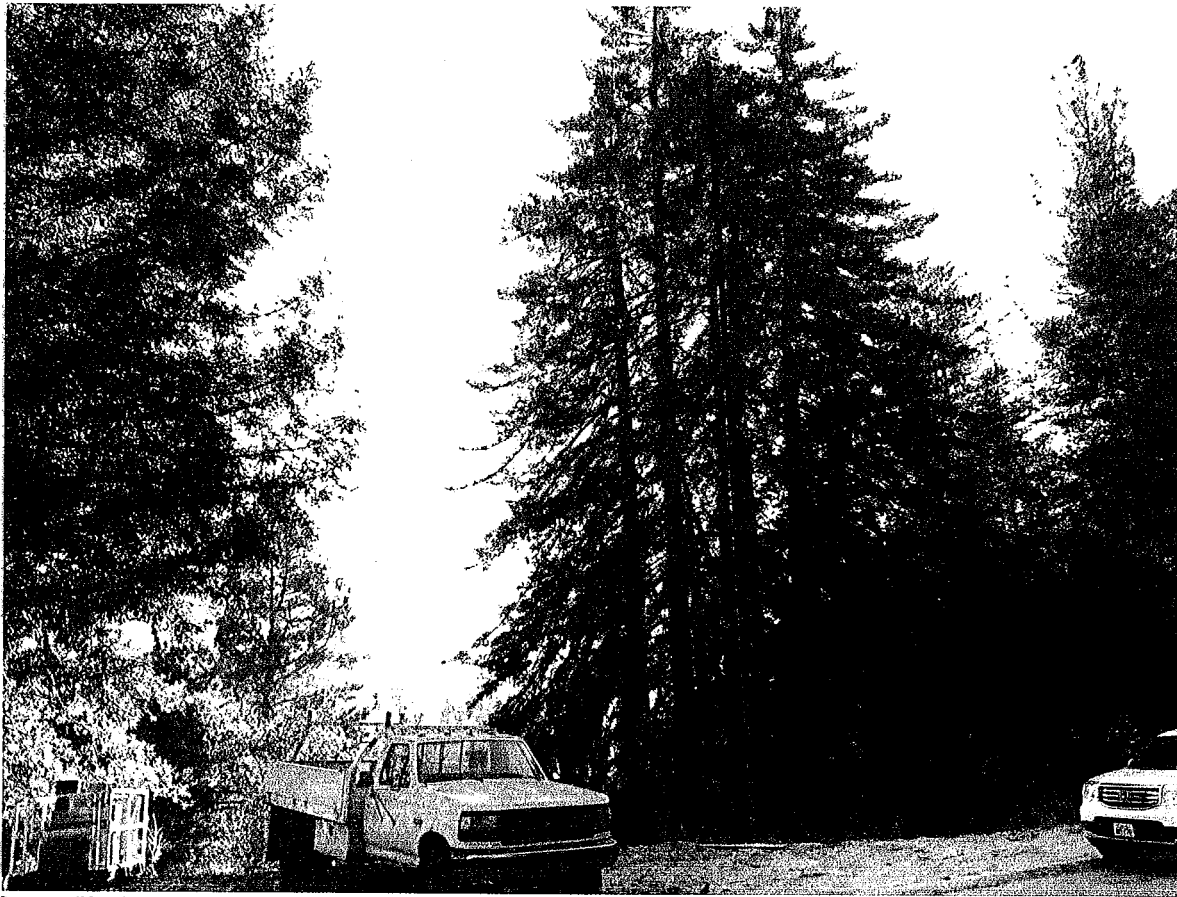
**Image #2 – Trees T5,T6,T7 & T8 – coast redwood. Trees to right of red line are on adjacent property.**
